eZono Service Documentation

QW-04: eZono 3000 Troubleshooting Guide

Document Number: eZono_3000_customer_troubleshooting_guide
Version: 1.1
Owner: Fenia Grypaiou
Date of Issue: 09 March 2015
Status: Approved

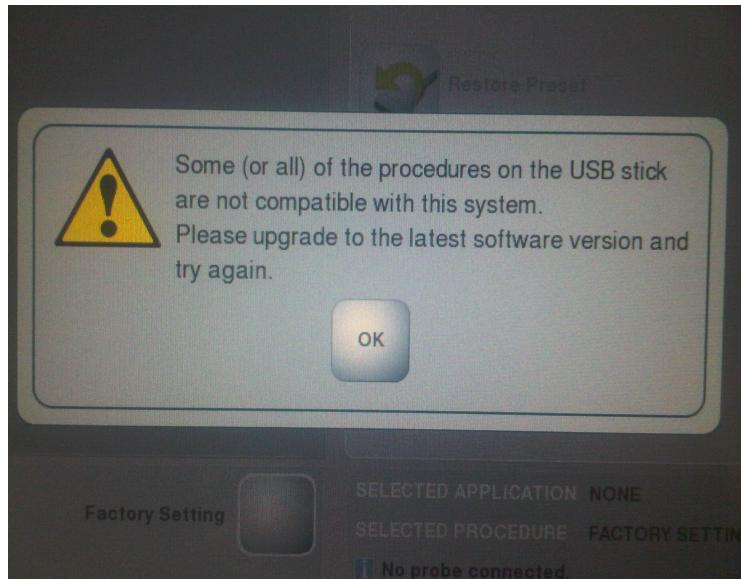
If the following message will appear on your screen while installing the CueCards then the only think that you have to do is to press the "OK" button and start again the installation.
